**CRASH INJURY INVESTIGATION**

**HU-1A BELL IROQUOIS HELICOPTER ACCIDENT**

**East St. Louis, Illinois**

**21 October 1959**

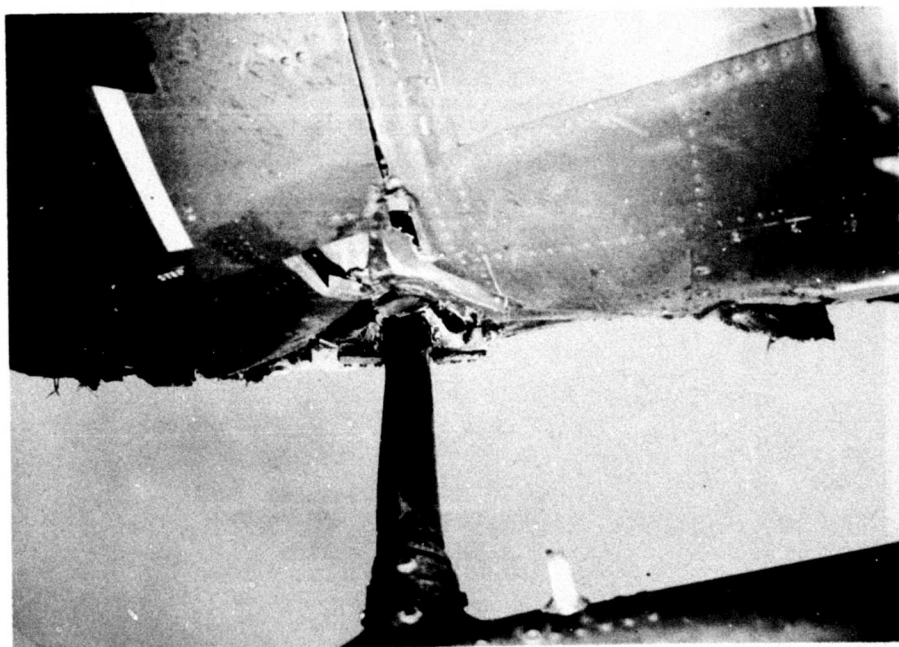
Fig. 43. Left aft cross-tube. Note damage to the fuselage (probably occurred at initial impact).

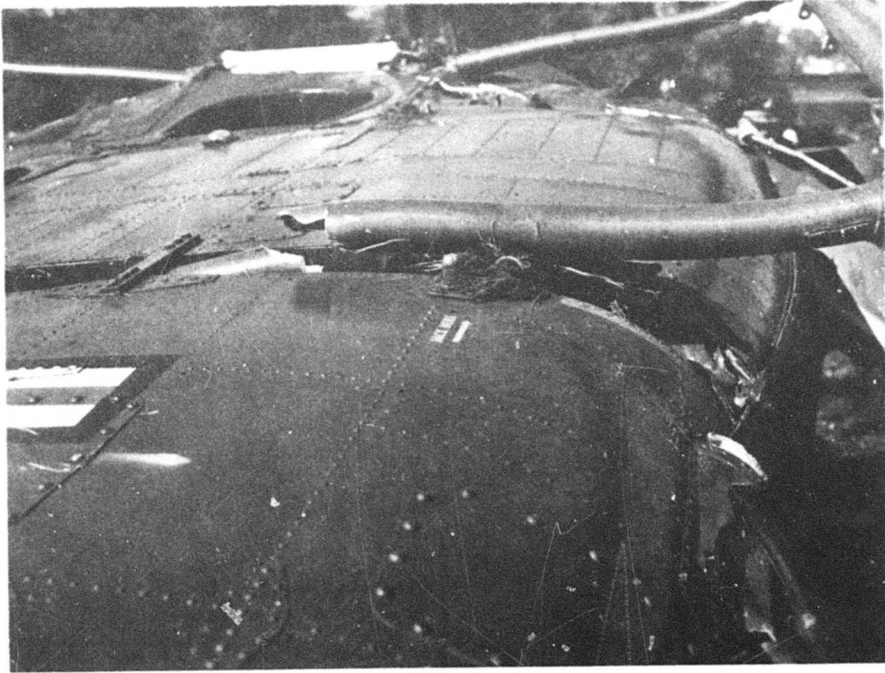
Fig. 44. Close-up of right front cross-tube failure indicates it had deflected to a great extent, absorbing vertical crash force.

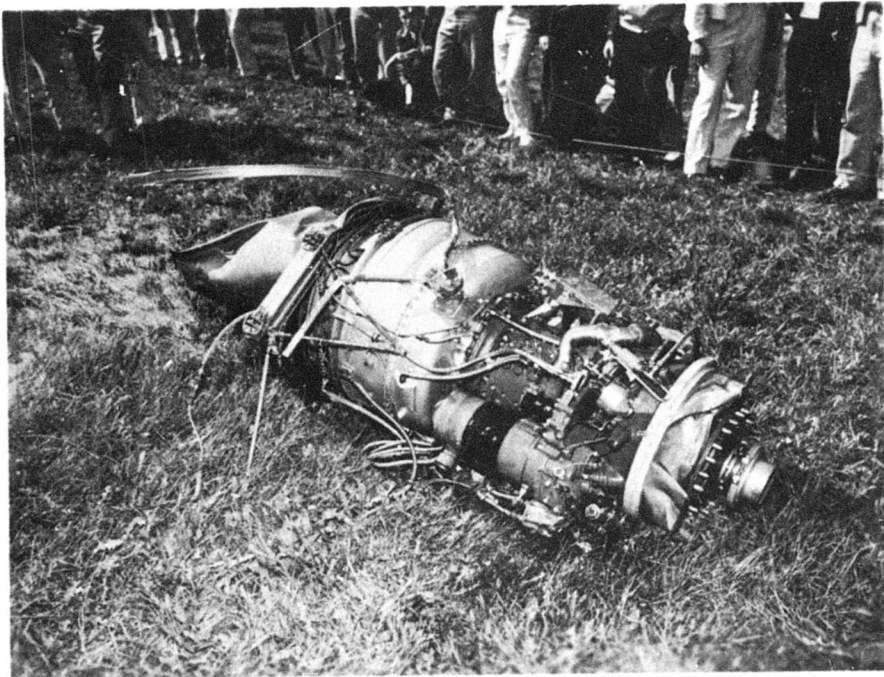
Fig. 45. HU-1A jet engine shown as it came to rest.

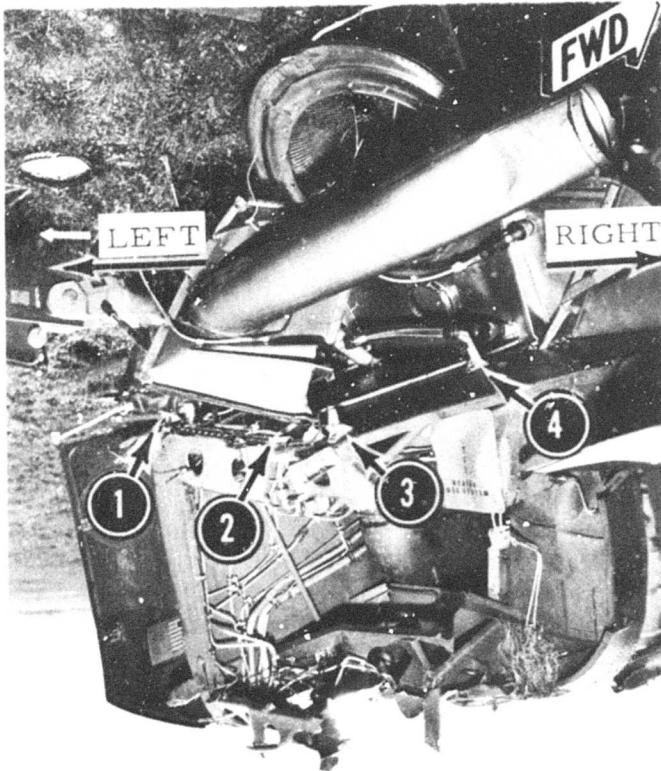
Fig. 46. Forward left (not shown) and aft left (arrow 1) engine mounts failed in compression. Center (arrow 2), aft (arrow 3), and forward (arrow 4) engine mounts failed in tension.

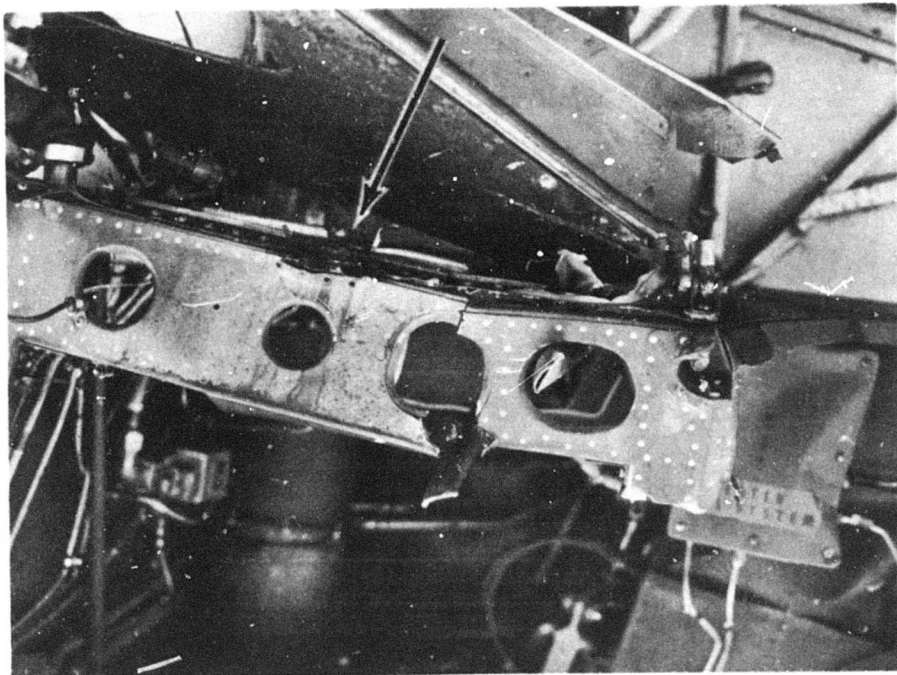
Fig. 47. Center engine mount aft (arrow) was torn free in an upward direction.

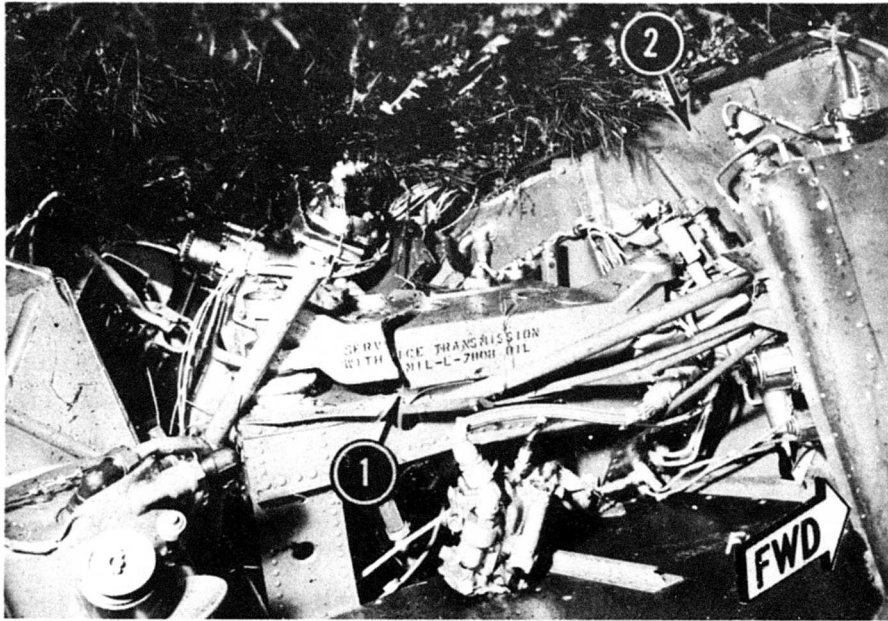
Fig. 48. Transmission mount (arrow 1) was cracked; transmission, rotor mast, rotor head and blades broke off completely to the left. Forward firewall bulkhead (arrow 2) is pointed out for orientation.

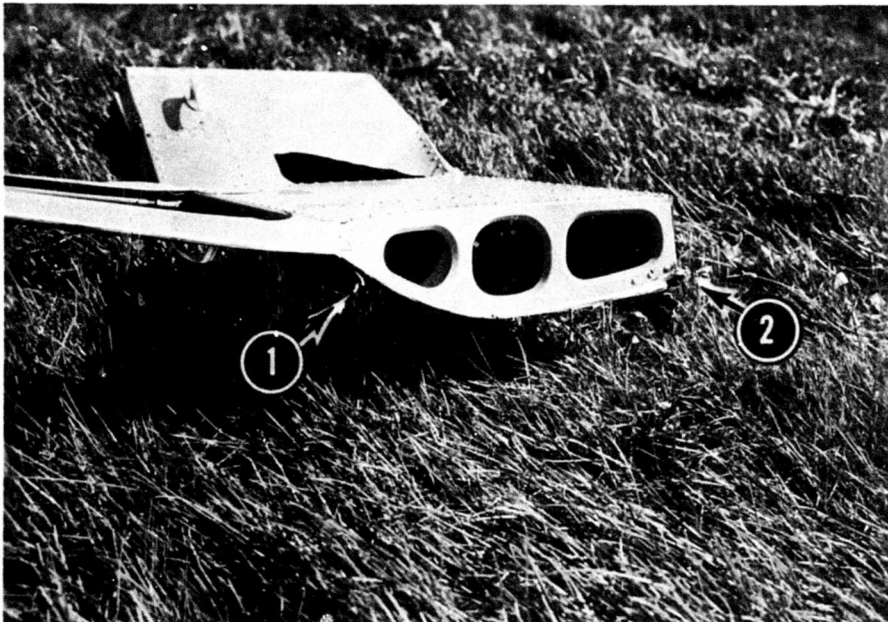
Fig. 49. Right front (pilot's) door, which was torn partially free at initial impact, was found at a point approximately 210 feet along the crash path. Both the upper (arrow 1) and the lower (arrow 2) hinges failed.

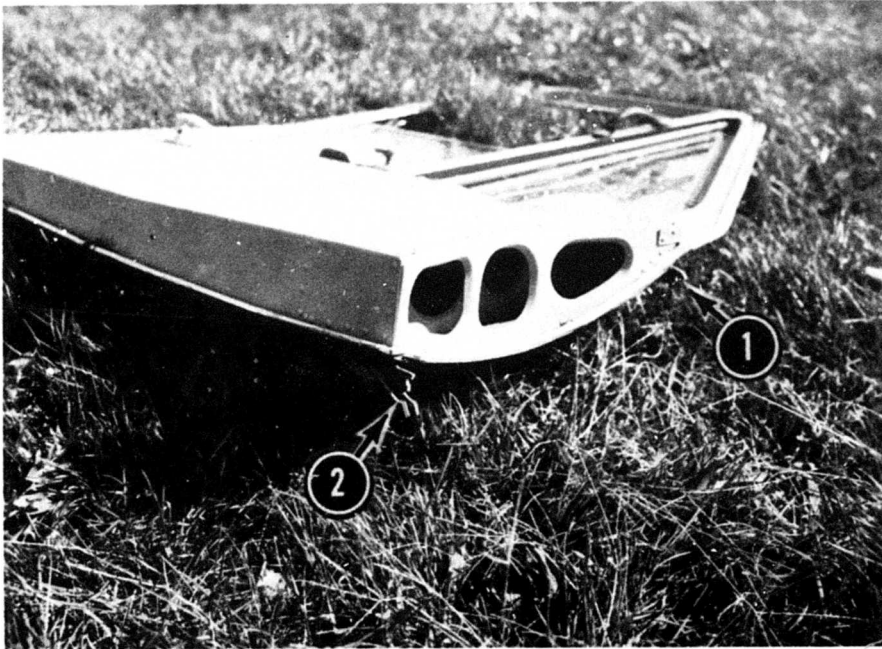
Fig. 50. Left front (copilot's) door, which was also torn partially free at initial impact, was found approximately 175 feet along the crash path. Both the upper (arrow 1) and the lower (arrow 2) hinges were torn free.

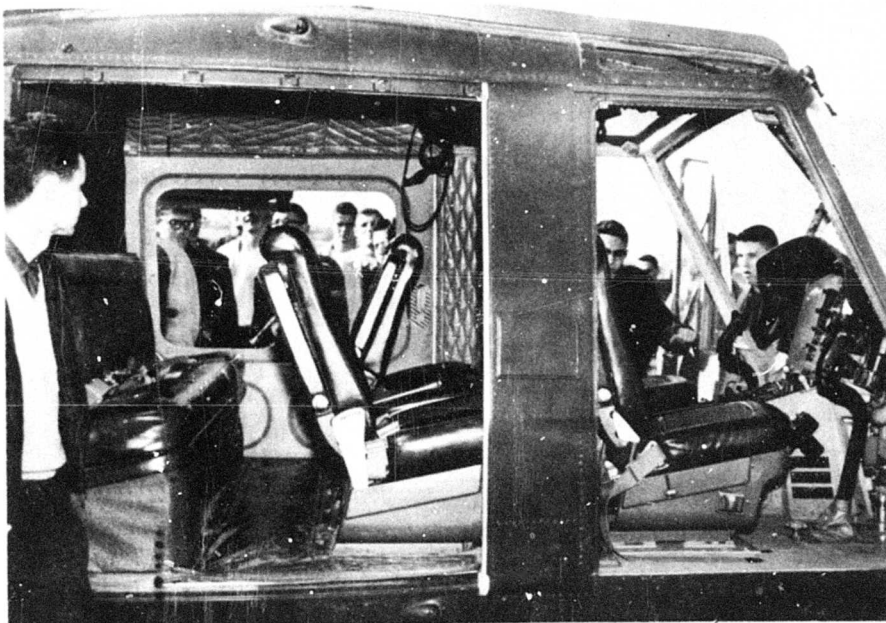
Fig. 53. Right side of HU-1A, showing installation of demonstration-type Teco seats (Model TE 432F-2). This photo was taken just prior to the flight on which the accident occurred.

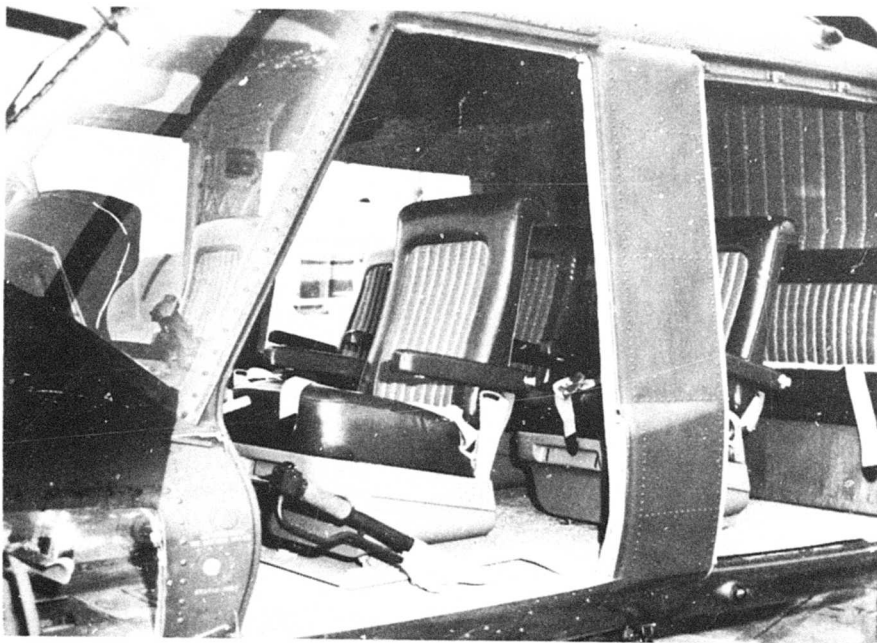
Fig. 54. Left side view - Bell Helicopter Corporation Photo - manufacturer's configuration. Note: The seats illustrated are not those normally utilized in the HU-1A helicopter. These seats were specially installed in this aircraft, which was to be used for demonstration and recruiting programs.

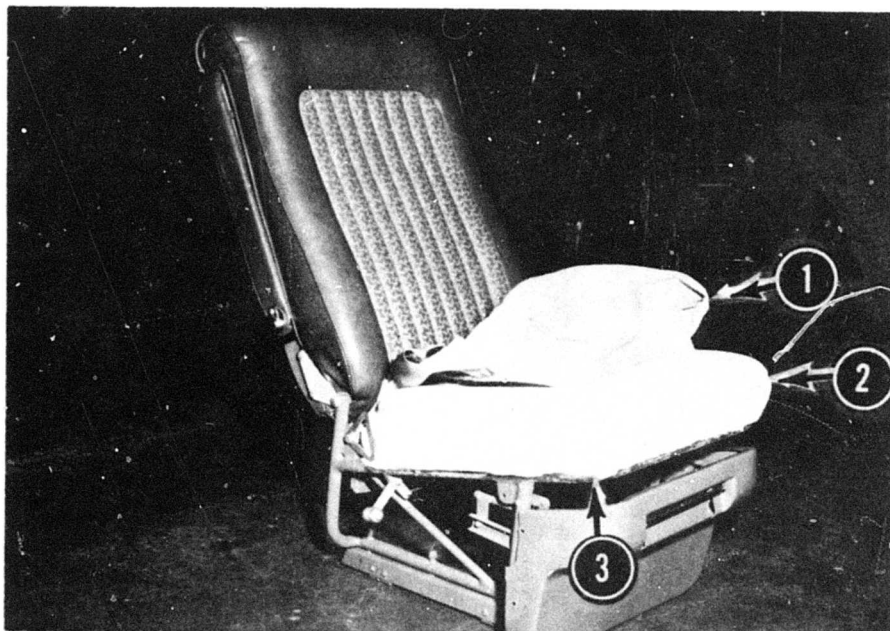
Fig. 59. Plastic (leatherette) upholstery (arrow 1) was removed from the seat cushion, revealing a 4-inch thick cushion of foamed polyurathane (arrow 2). This cushion was cemented to the top of the seat pan (arrow 3).

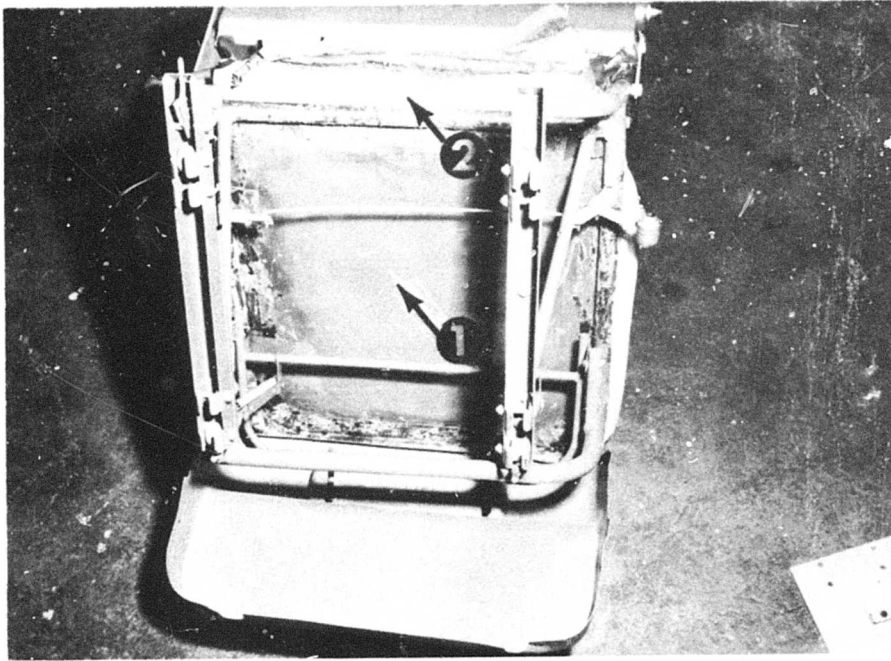
Fig. 60. The bottom of the seat pan (arrow 1) is a sheet of nylon material impregnated with neoprene. This sheeting has been stretched tight over a frame of chrome-moly tubing (SAE 120) and bonded to the tubing (arrow 2).

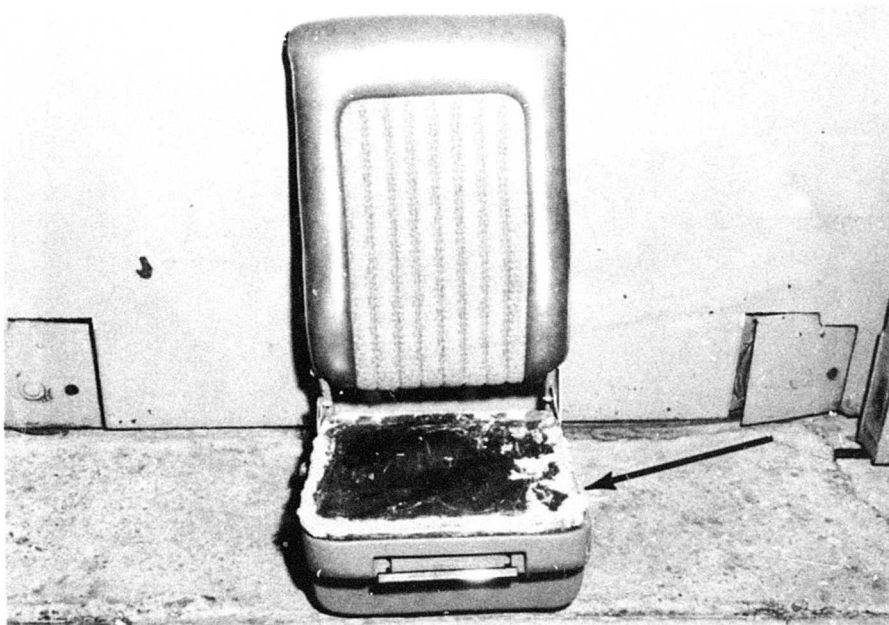
Fig. 61. Polyurathane cushion, cemented to the neoprene-impregnated nylon seat pan, is removed. The seat pan does not appear to have any degree of yield or stretch.

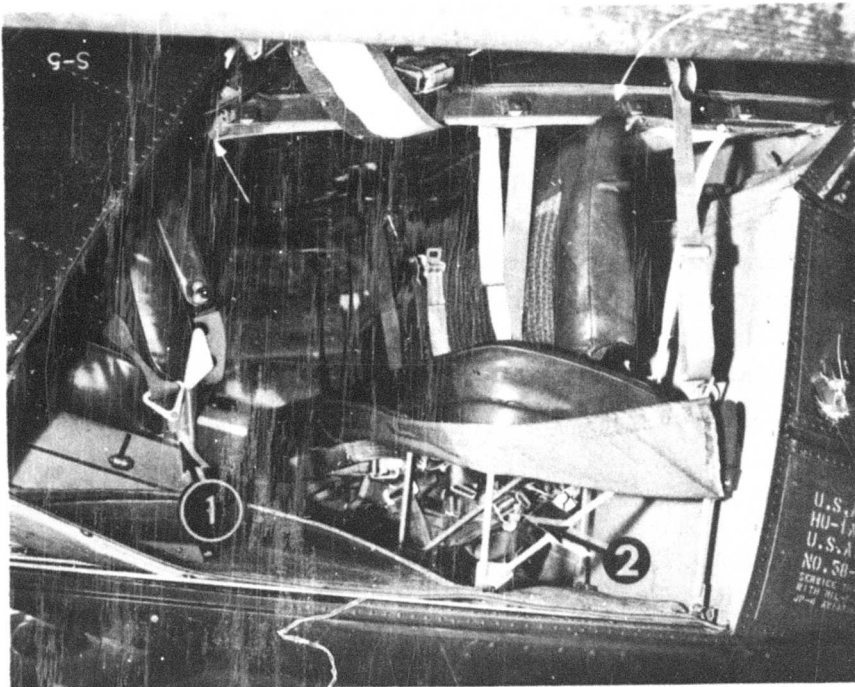
Fig. 64. Safety belt anchorages on single seats are designed to be flexible for force application in one plane only; they pivot on their attaching bolts (arrow 1). Note parachutes and harness stored beneath rear passenger seat (arrow 2).

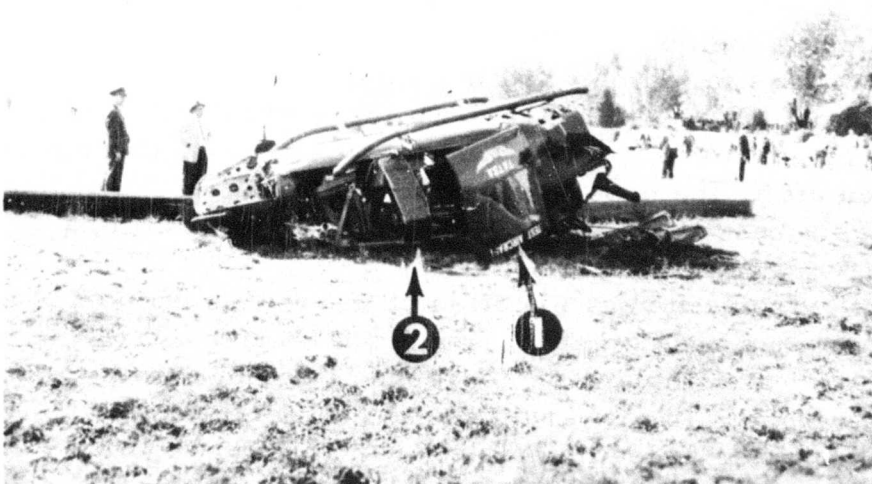
Fig. 65. Right side of helicopter. Cargo door (arrow 1) was out of its track, but still attached to the fuselage. Note inward deformation of "roof" structure and buckling of vertical support member (arrow 2).

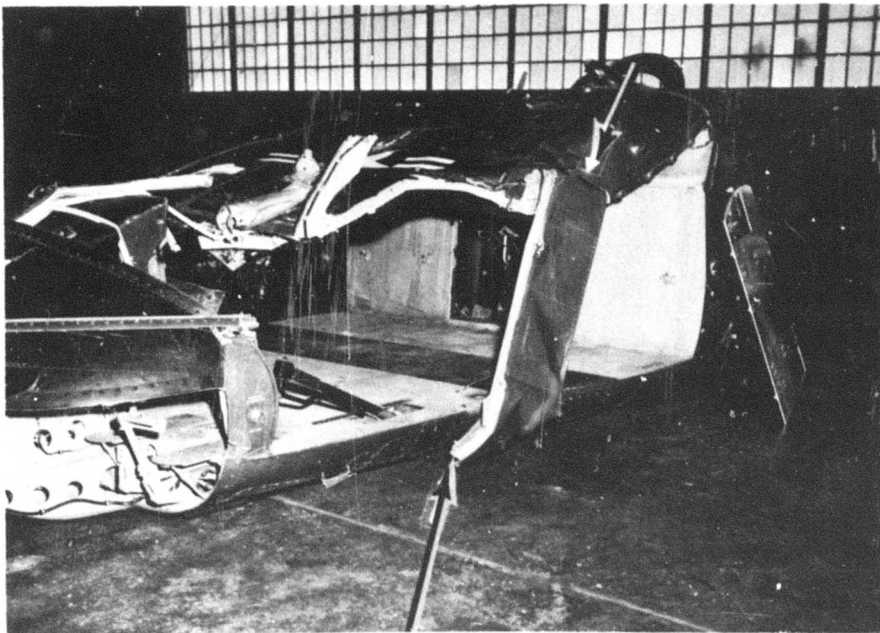
Fig. 66. Left side of fuselage (seats removed). Vertical overhead support (arrows) failed. (See Fig. 67).

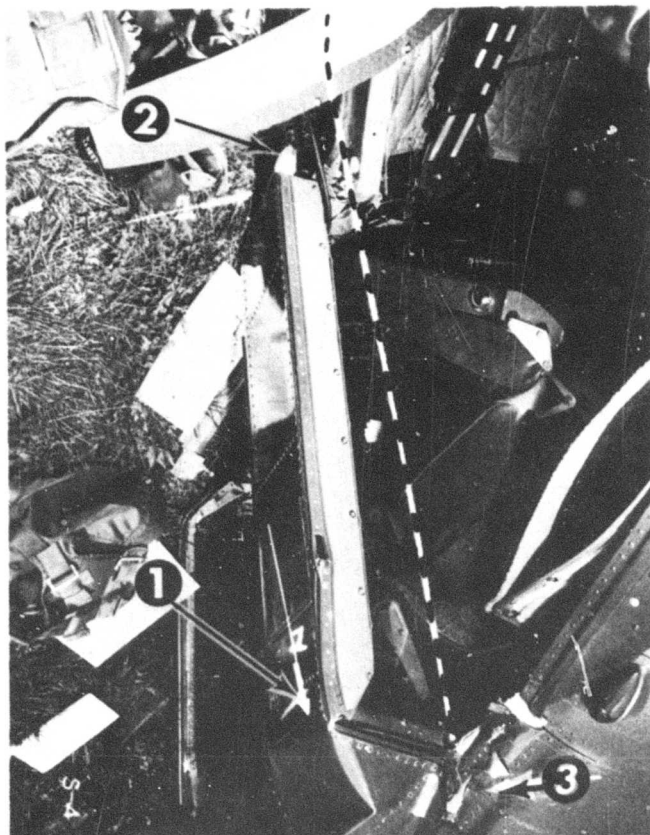
Fig. 68. Left support member, aft edge (looking forward). Note compression buckling (arrow 1). Dotted line indicates normal position. Failure of this member occurred both at the top (arrow 2) and bottom (arrow 3) attachments.

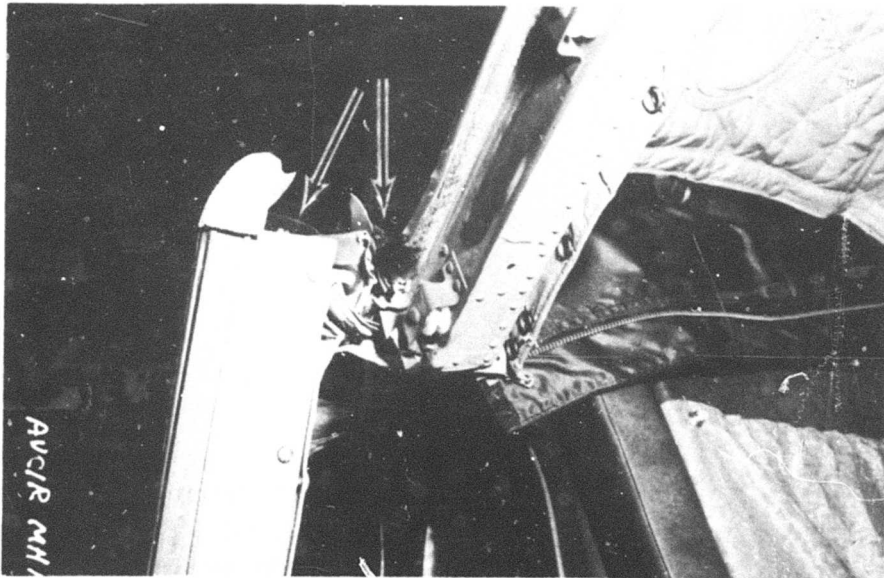
Fig. 69. Left support member, aft edge, top (looking forward). Failure (arrows) is believed to have occurred during final rolling of the fuselage onto its back. Failure of this structure outward, as it occurred, is more desirable than failure inward would be.

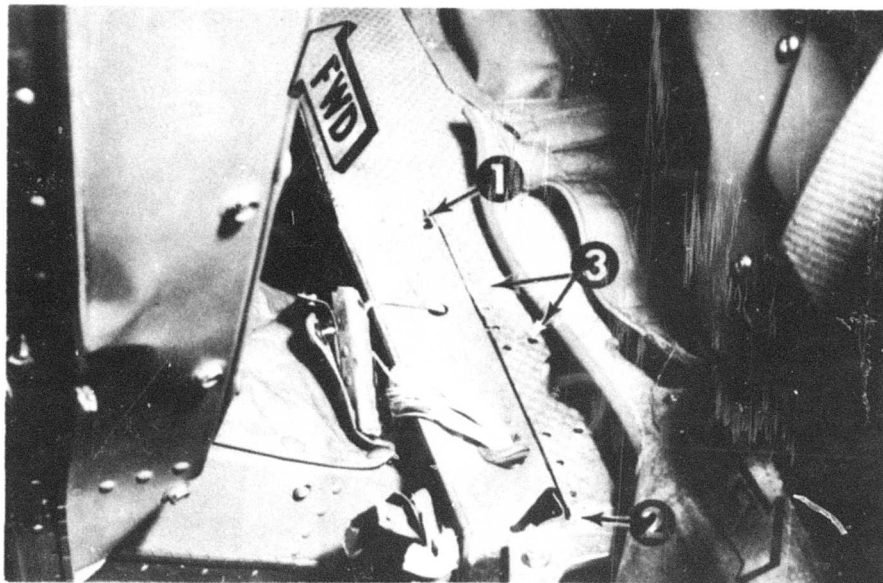
Fig. 70. Left support member, lower attachment points. The triangular cutouts (arrows 1 and 2) allow "L" stringers to pass through vertically. The "L" stringers and the inner and outer skin of the support member attach the member to the fuselage. The line of rivet holes (arrow 3) indicate where the skin attaches to the floor.

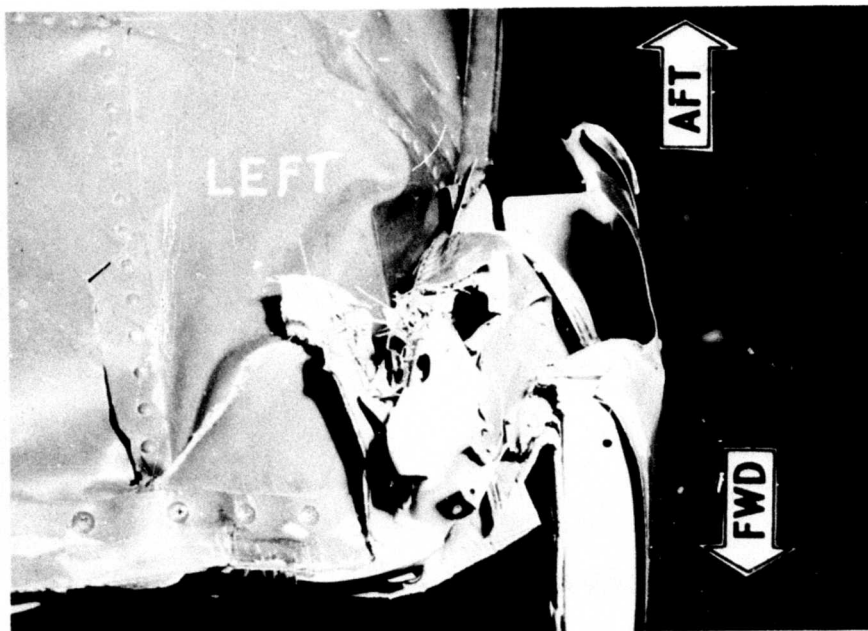
Fig. 72. Left vertical support member, upper attachment point. It does not appear that the "L" stringers extend up to the top of this member for attachment. Inner and outer skin appears to be largely relied upon, in addition to other structural attachment methods, to provide integrity.

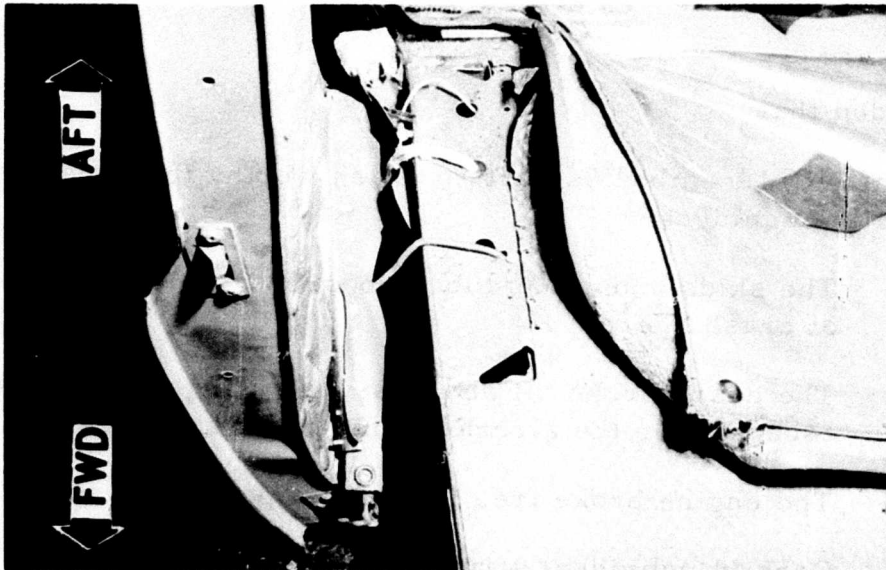
Fig. 73. Right vertical support member, lower attachment point. Failure of this area is essentially the same as the left. Forward and aft "L" stringers and outer skin and inner skin attachments all failed, a condition that allowed the support member to tear free.

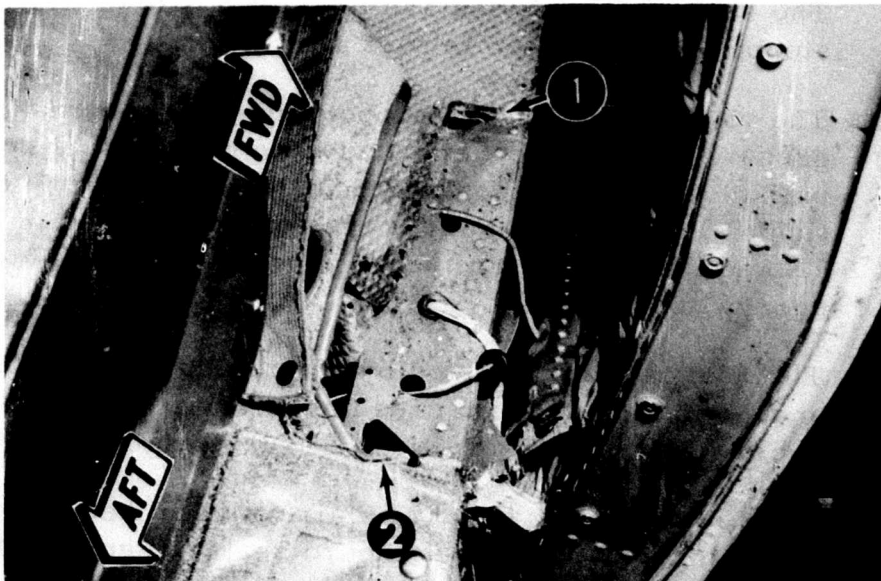
Fig. 74. Right vertical support member, lower attachment point. Depth and type of failure of forward "L" stringer is shown by arrow 1 (as compared to that of aft "L" stringer). Arrow 2 indicates some application of force against the upper area of the member in an aft direction during its failure.
